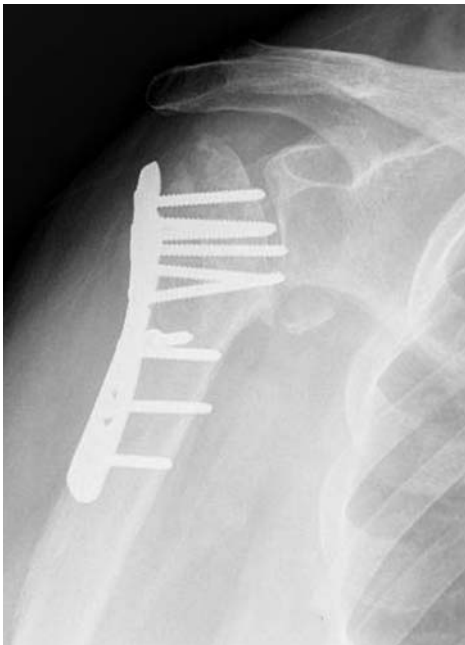
*Fig. 1 Proximal humerus locking plate failure with joint penetration.*

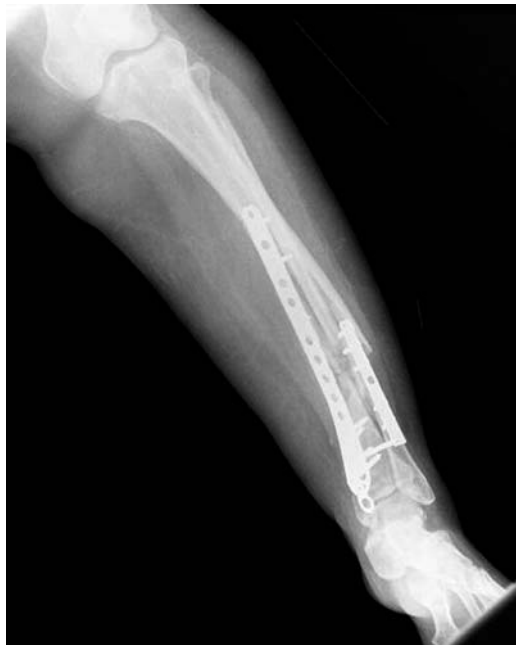
*Fig. 2 Locked construct failure with new tibia shaft fracture.*

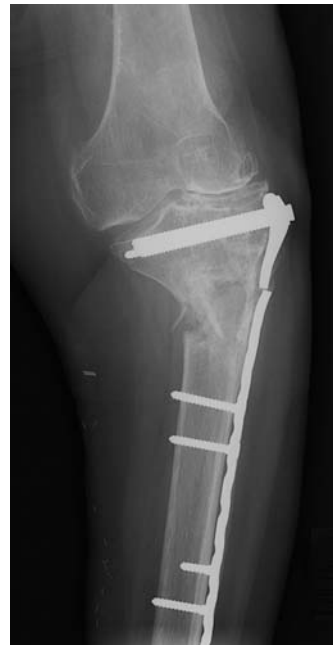
*Fig. 3 Bridge plating with plate fatigue failure through unplugged locking screw hole.*
