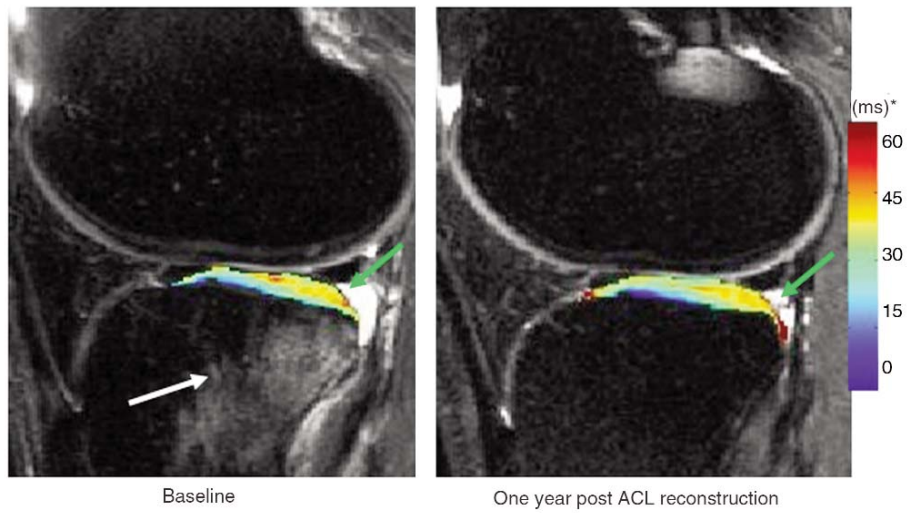
Fig. 1 In these sagittal images of a knee at baseline and at one year after ACL reconstruction, high T1rho values (warmer colors) represent cartilage injury and loss of proteoglycan while lower T1rho values (cooler colors) represent more normal cartilage composition. At baseline, the cartilage overlying the BMEL (white arrow) have high T1rho values (green arrow). At one year after ACL reconstruction, the cartilage shows persistent damage (green arrow) despite resolution of BMEL.
